Evaluation of Deep, Open Drains in the North Stirling Area

**R. Ferdowsian
A. Ryder
J. Kelly**

Resource Management Technical Report 161

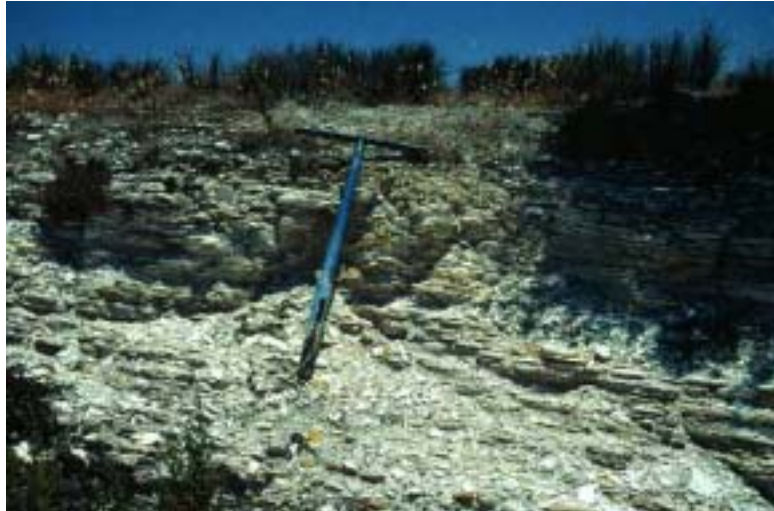
Photo 1: Sedimentary layers of the Pallinup silty clay in the study area.

The area is covered by Pallinup Siltstone which is a Tertiary Formation. The Pallinup sediments in this area, are mainly composed of fine silt, clay (Photograph 1) and occasionally fine to medium sand (Table 1). The siltstone, in some areas, contains pink and white spongolite (a siltstone full of sponge spicules). The Pallinup Siltstone overlays the basement rock which is of Precambrian origin and part of the Yilgarn Craton. There are basement (granite and gneiss) highs in the area that are covered by sediments. Weathered granite can be seen along the bed of the main drain (Figure 1).

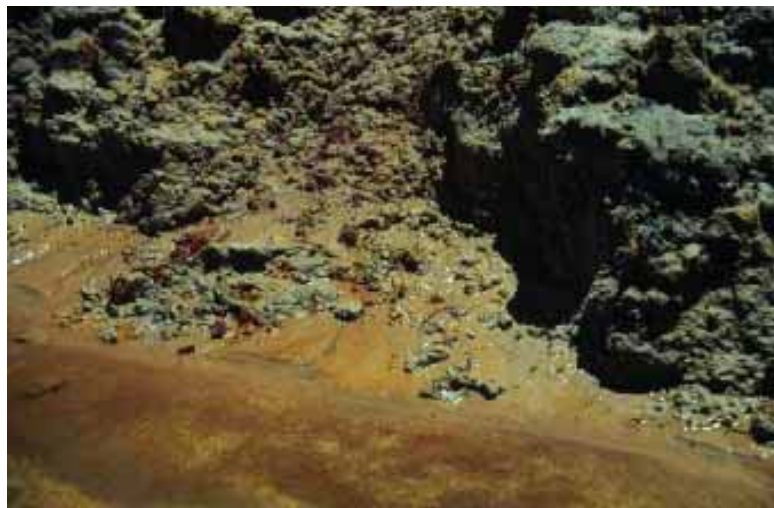
Photo 2: One of the few major seepage zones. Note: the collapse of material at the seepage zone which is in the centre of the photograph.

We recorded the position of major seepage zones (Figure 1 and Photograph 2) which were along the mid section of the drain.

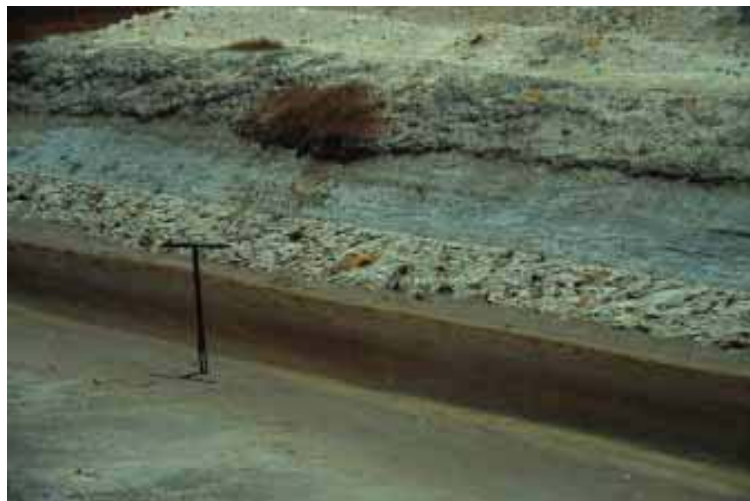
Photo 3: With the exception of a few sites, the soil profile along the main drain is very tight silty clay. Note: The bed of the drain is filled with silt.

Some sections of the main drain were badly eroded. Gullies, 1 m apart and up to 0.5 m deep, had formed along the sideslopes in some sections of the main drain (Photograph 4). Part of the eroded material had filled the base of the main drain (Photograph 3) and part was transported out of the area. There were also indications of sedimentation further downstream. A typical site where this silting may be seen is 500 m before the creek crosses the South Formby Road (Figure 1). On the 1985 aerial photographs there are four pools in this area. These pools are absent on the 1993 aerial photographs. It is likely that these pools have been filled with silt between 1985 and 1993. Silting of the creek bed can also be seen further downstream, east of the South Formby Road.

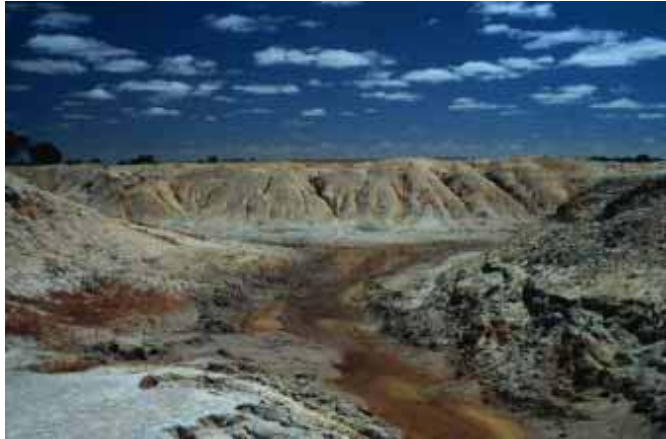
Photo 4: The slopes of the main drain are badly eroded.

- gully erosion due to storm water dropping into the drain channel;
- siltation and movement of sediments due to the collapse of banks and gully erosion;

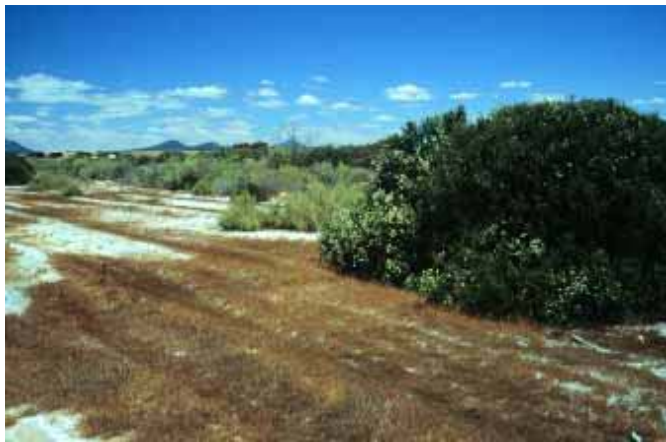
Improvement of creek beds and flood plains (eg. Area 2; Figure 3) could be partly attributed to them being fenced off and revegetated with salt-tolerant species. These areas had been mounded and planted with salt-tolerant species. *Melaleuca thyoides*, *Acacia saligna* and *Atriplex spp.* were among the surviving plants. *Melaleuca thyoides* was very impressive (Photograph 5) with a large canopy (5m in diameters) and healthy growth.

Photo 5: Melaleuca thuyoides (foreground) had more impressive growth than Atriplex spp. (saltbush).

Deep drains are costly (2500 to 8000 \$/km) to construct and to maintain. Therefore a feasibility study should be done before they are constructed. In most cases, the money is better spent on other conservation work, such as shallow surface drains (\$500 to \$1000/km). These are more cost-effective than deep drains. In addition, shallow surface drains should always be tried first, before embarking on ambitious deep drains. Fencing off the potentially saline areas and planting salt tolerant species such as *Melaleuca thyoides* which has an impressive, large canopy (5 m in diameter) and seems to be more salt tolerant than *Acacia saligna* and saltbush, is also recommended.

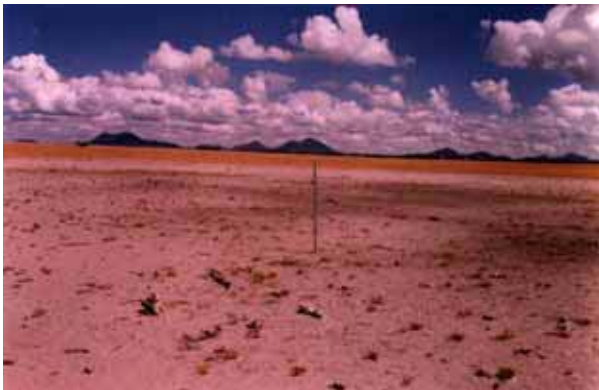
The improved area, furthest from the drain which was cropped in 1996 was a 3 ha patch of land (Area 3; Figure 3) up to 200 m away from the main drain. Improvement of this land is entirely due to the effects of the drain since there is no treatment other than the drain. The area was bare in 1985 (Photograph 6a). At the time of our second visit (December 1996), this area had been cropped but not harvested because the crop (barley) looked patchy. The Geonic EM38 readings on this area were between 80 and 120mS/m. These reading showed that the area was still moderately salt-affected. Photograph 6b shows lupins grown in the area in 1995. This land is probably on a sandy lens that crosses the deep drain (Site S1; Figure 1). By having a high hydraulic conductivity, this sandy lens has extended the effect of the drain far beyond the expected distance. We observed one section (Site S1; Figure 1) of the deep drain that had higher seepage rates than other areas and found that the sandy lens crossed the drain here.

Photo 6a : This area was extremely salt-affected and bare in April 1985.

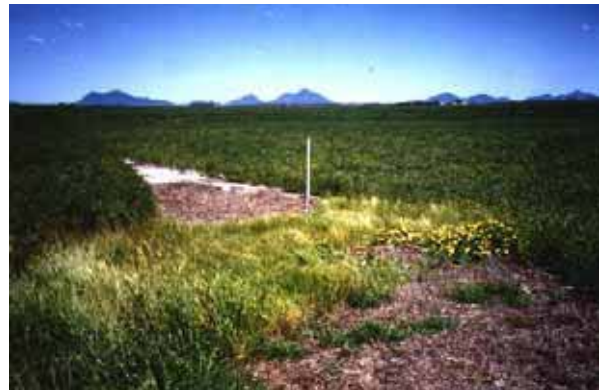
Photo 6b: The same area in September 1995 growing a crop of lupins.

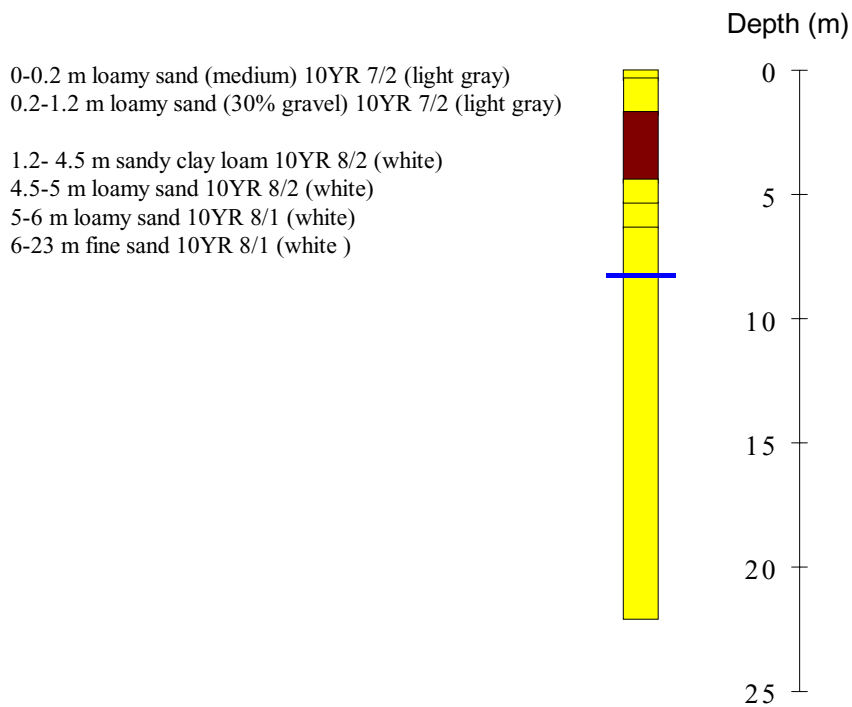
KP1/95

Easting: 592550 **Northing:** 6222928

Groundwater salinity (mS/m): 1075 **Water level below ground (m):** -8.7

Landform Pattern: Lunette Fields

Interpreted Lithology: Tertiary Pallinup Formation

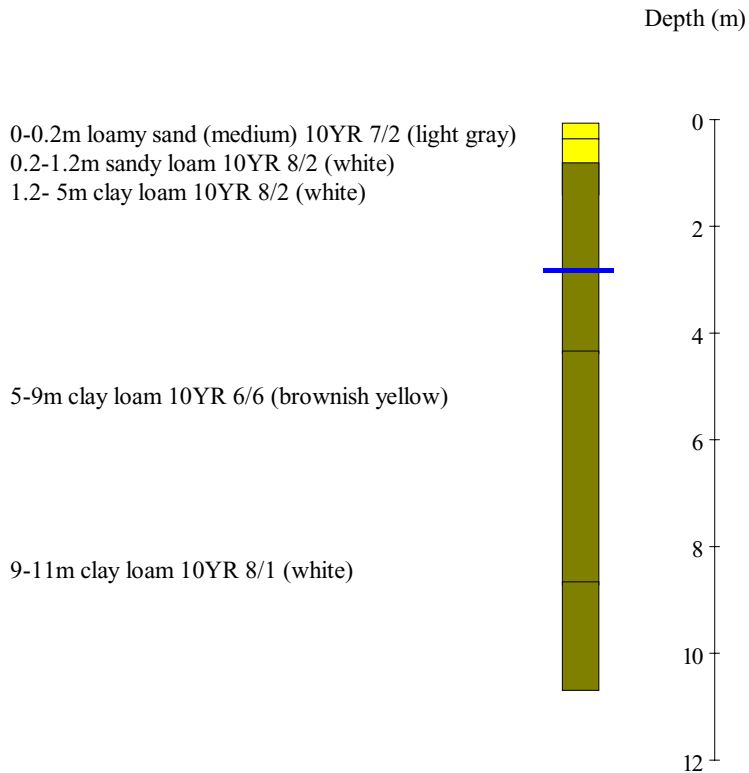
KP4/95

Easting: 589720 **Northing:** 622114

Groundwater salinity (mS/m): 5870 **Water level below ground (m):** -2.8

Landform Pattern: Stagnant Flats

Interpreted Lithology: Tertiary Pallinup Formation
